auri research brief

No.89

Improving Basement Parking Lot Entrances for Better Pedestrian Safety

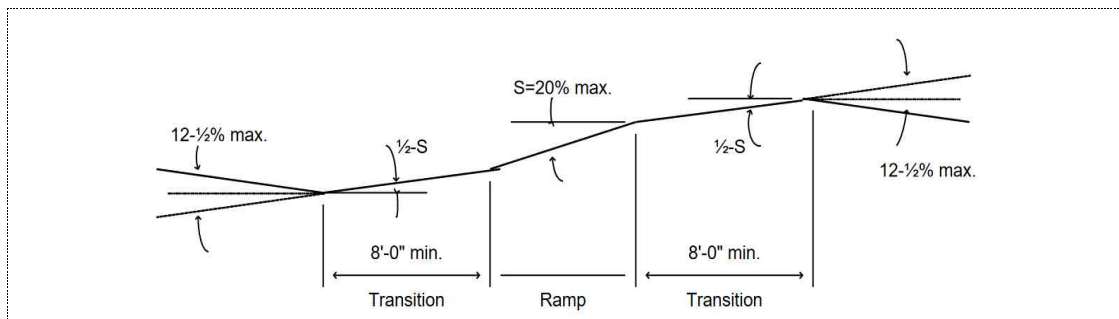
According to the parking lot design standards set by the City of Los Angeles Department of Building and Safety (LADBS), ramps with a longitudinal slope of 12.5% or greater should have transition sections that reduce the slope by about half, with a minimum length of 2.4m.

Diagram of LADBS (USA) Standards for the Longitudinal Slope of Driveways

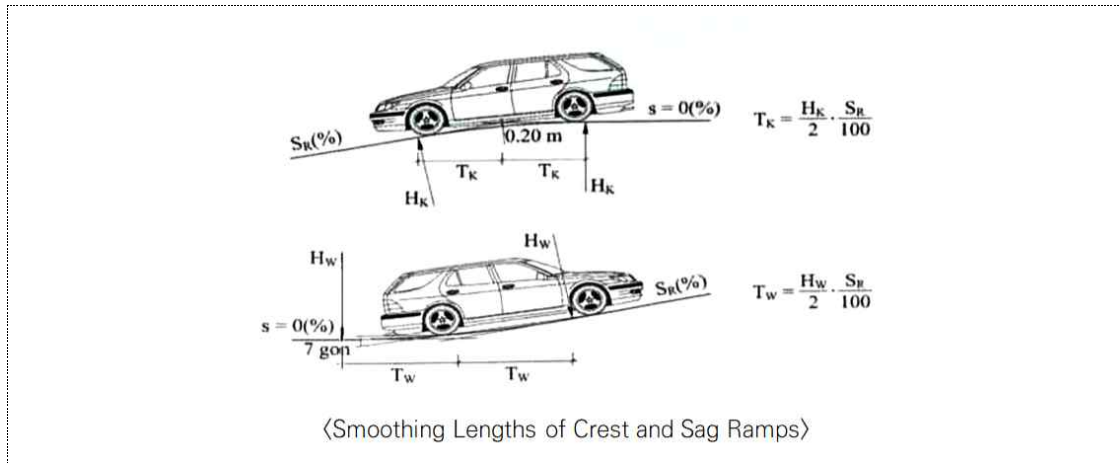
German guidelines on parking facilities stipulate that ramps with a longitudinal slope of 8% or greater should have transitional sections that reduce the slope by approximately half. The length of the transition section, in this case, differs depending on the type of slope. Crests should measure from 1.20m to 2.55m, and sags should be at least 2.00m to 4.25m in length.

Measuring the Horizontal Length of the Transition Section with Circular Curves

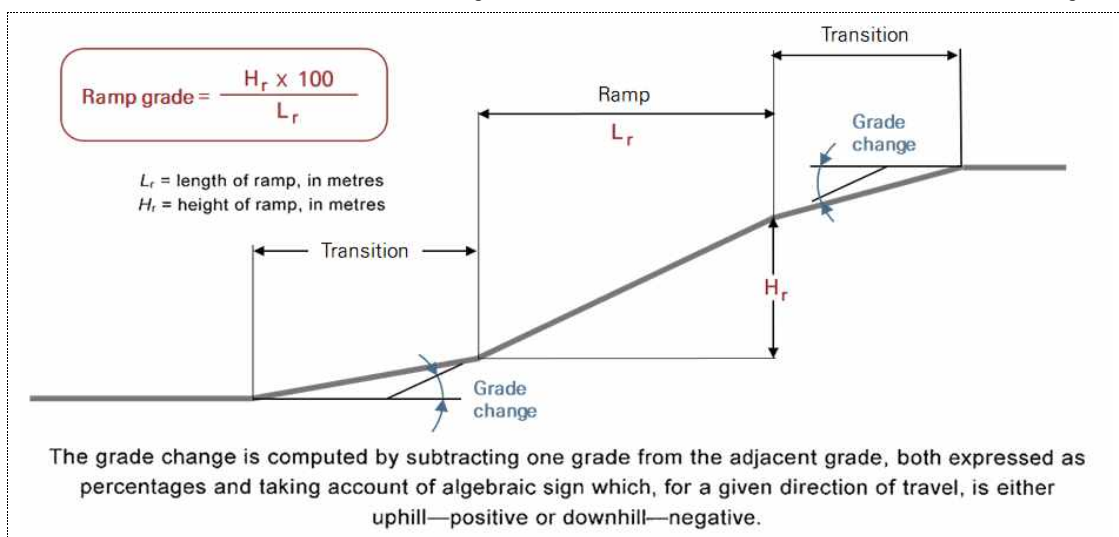
The Australian/New Zealand standards require ramps with longitudinal slopes of 12.5% (crest) or 15% (sag) or greater to have transition sections installed, which should be at least 2m long.

Australian/New Zealand Standard for Setting the Standard Grade of Transition Sections for Smoothing

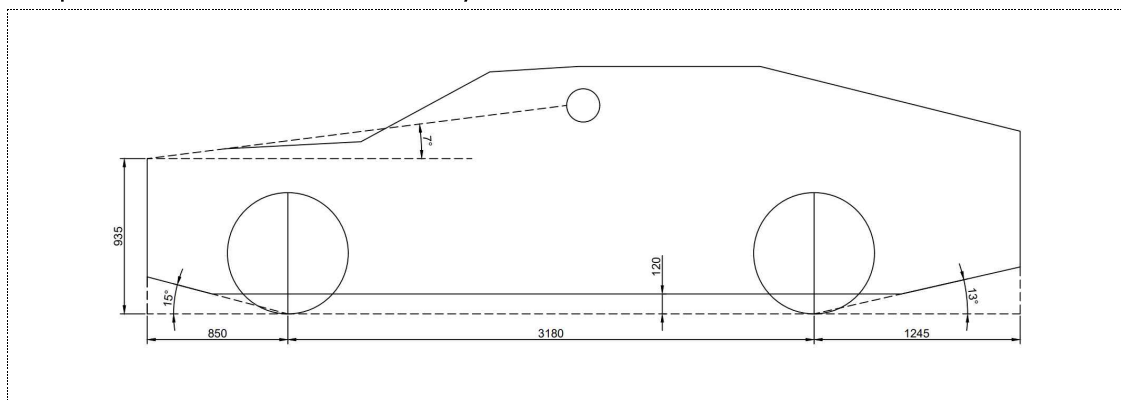
A vehicle currently in the market with the most disadvantages was chosen for the analysis. Considering that many types of vehicles use basement parking lots, off-road parking lots and annexed parking lots with ramps, it is essential to use a vehicle with appropriate specifications for the analysis so as to develop standards for transition sections by longitudinal slope that account for such diversity. For this purpose, this study reviewed various specifications, including the wheelbase, the level of the driver's observation point, and the front and back overhang distances, and selected the G model from H company as the subject of the analysis, as it had the most unfavorable specifications.

Shape of the Vehicle Selected for the Analysis

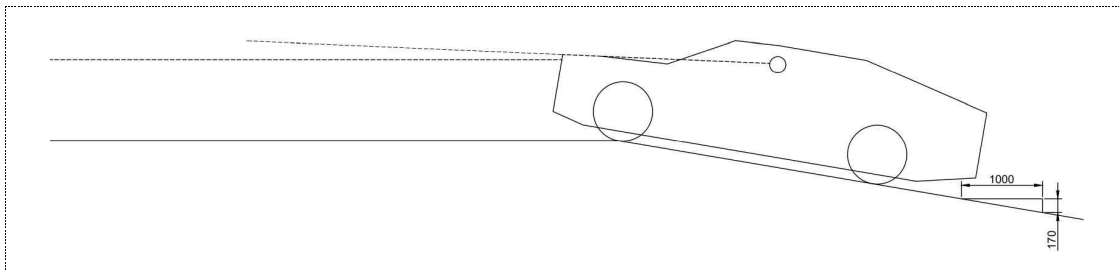
By applying such experimental conditions, this study simulated the forward blind spots from the vehicle selected for the analysis at the end of the ascending ramp under various longitudinal slopes. First, there were no forward blind spots when the car was on a flat road, just as in the experiment conducted by the Korea Transportation Safety Authority. However, on a ramp with a 17% slope, the maximum longitudinal slope set by the current parking lot structure and equipment standards, a one-meter-tall child pedestrian could not be seen from any location from the car at the end of the ramp. This indicates that a driver would be unable to spot a child pedestrian at the point where the car enters the road and that pedestrian safety cannot be ensured without a transition section.

Simulation Result of a Driver Blind Spot on a 17% Longitudinal Slope

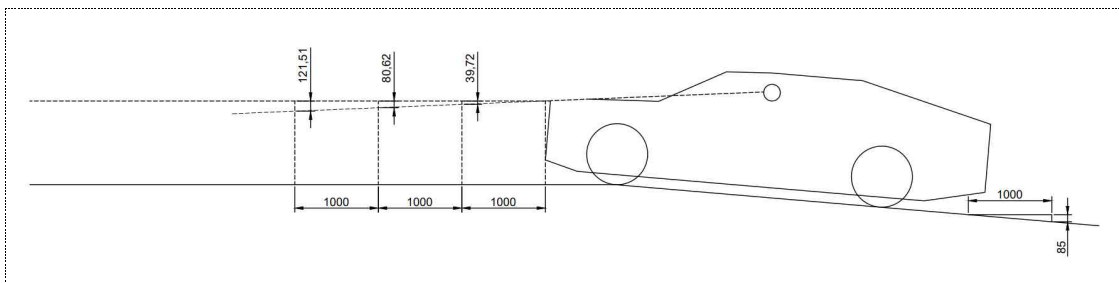
When the longitudinal slope was set to 8.5%, there was a one-meter blind

spot in the front such that the driver was able to spot a child pedestrian who was taller than one meter in front of the car. To achieve this effect, a transition section of at least 3.2 meters, which is the wheelbase of the vehicle, was used in the analysis. Therefore, to prevent a forward blind spot at the entrance of a basement parking lot, a transition section with a longitudinal slope of 8.5% or less and at least 3.2 meters in length should be installed at the crest ramp where the slope changes.

Simulation Result of a Driver Blind Spot on an 8.5% Longitudinal Slope

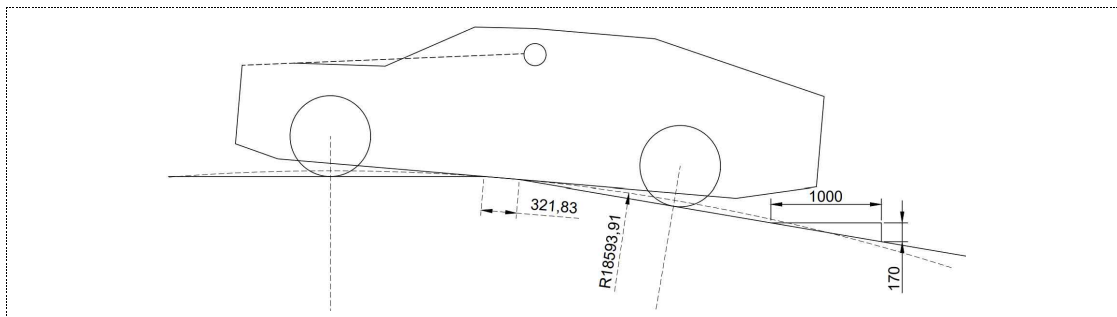
Next, this study analyzed the standards for transition sections to prevent damage to the undercarriages of vehicles. For the start and end of crest ramps, a simulation on a 17% longitudinal slope showed that the undercarriage of the vehicle touches the ground, thus confirming the need for transition sections. There was no contact at the start or end of sag ramps, but previous research (Kim *et al.*, 2014) confirmed that the undercarriages of vehicles could touch the ground depending on their movements, even at the start and end of sag ramps.

Simulation Result of Ground Contact on Crest Slopes at the Point of a Slope Change

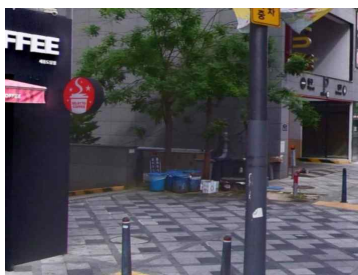
Poor Examples of Parking Lot Warning System Installations

At the parking lot exit

Next, this study analyzed the visibility of the warning systems. In 45.2% of parking lots with warning systems, the warning systems were difficult to spot due to their surroundings. The cases in which pedestrians on both sides could notice the warning systems amounted to 61.3%, while the systems were difficult to spot in 12.9% of the parking lots. This indicates that even if the warning system is installed in a highly visible location, it is difficult for pedestrians to spot it if the surrounding environment is improperly maintained.

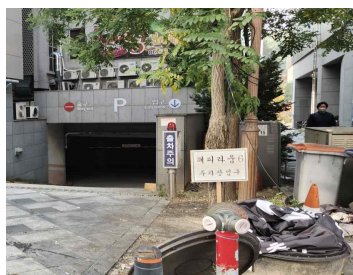
At the front of the parking lot

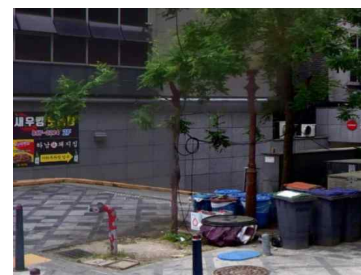
At the parking lot entrance

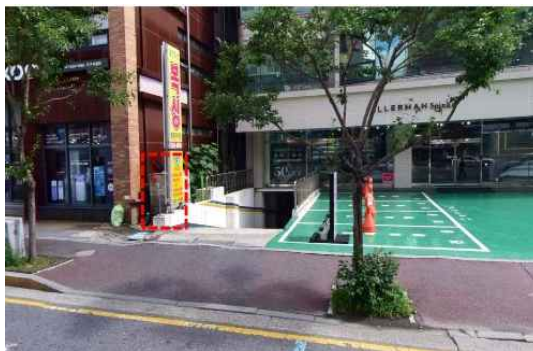
Improvement Strategies for Installing Safety Facilities (Warning Systems) at Parking Lot Entrances (Example)

Current Status

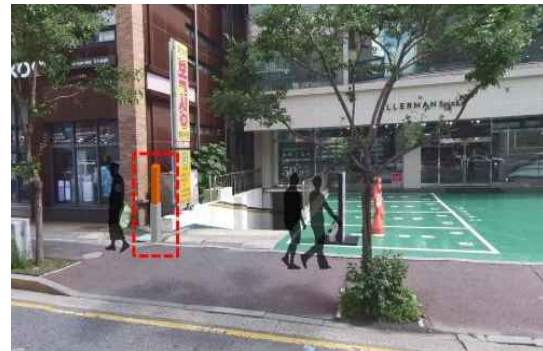
Proposal for Improvement

warning systems should be established to ensure that the warning systems cannot be randomly deactivated. In addition, the warning systems should be installed with lighting in highly visible locations to ensure the safety of pedestrians, including those with hearing loss, as noted above. Based on the findings from the field research, this study proposes detailed standards that require warning systems to be located within three meters of the parking lot exit, to be easily visible to pedestrians, and to generate an alarm sound of 50 dB or more.
